NATIONAL AERONAUTICS AND SPACE ADMINISTRATION

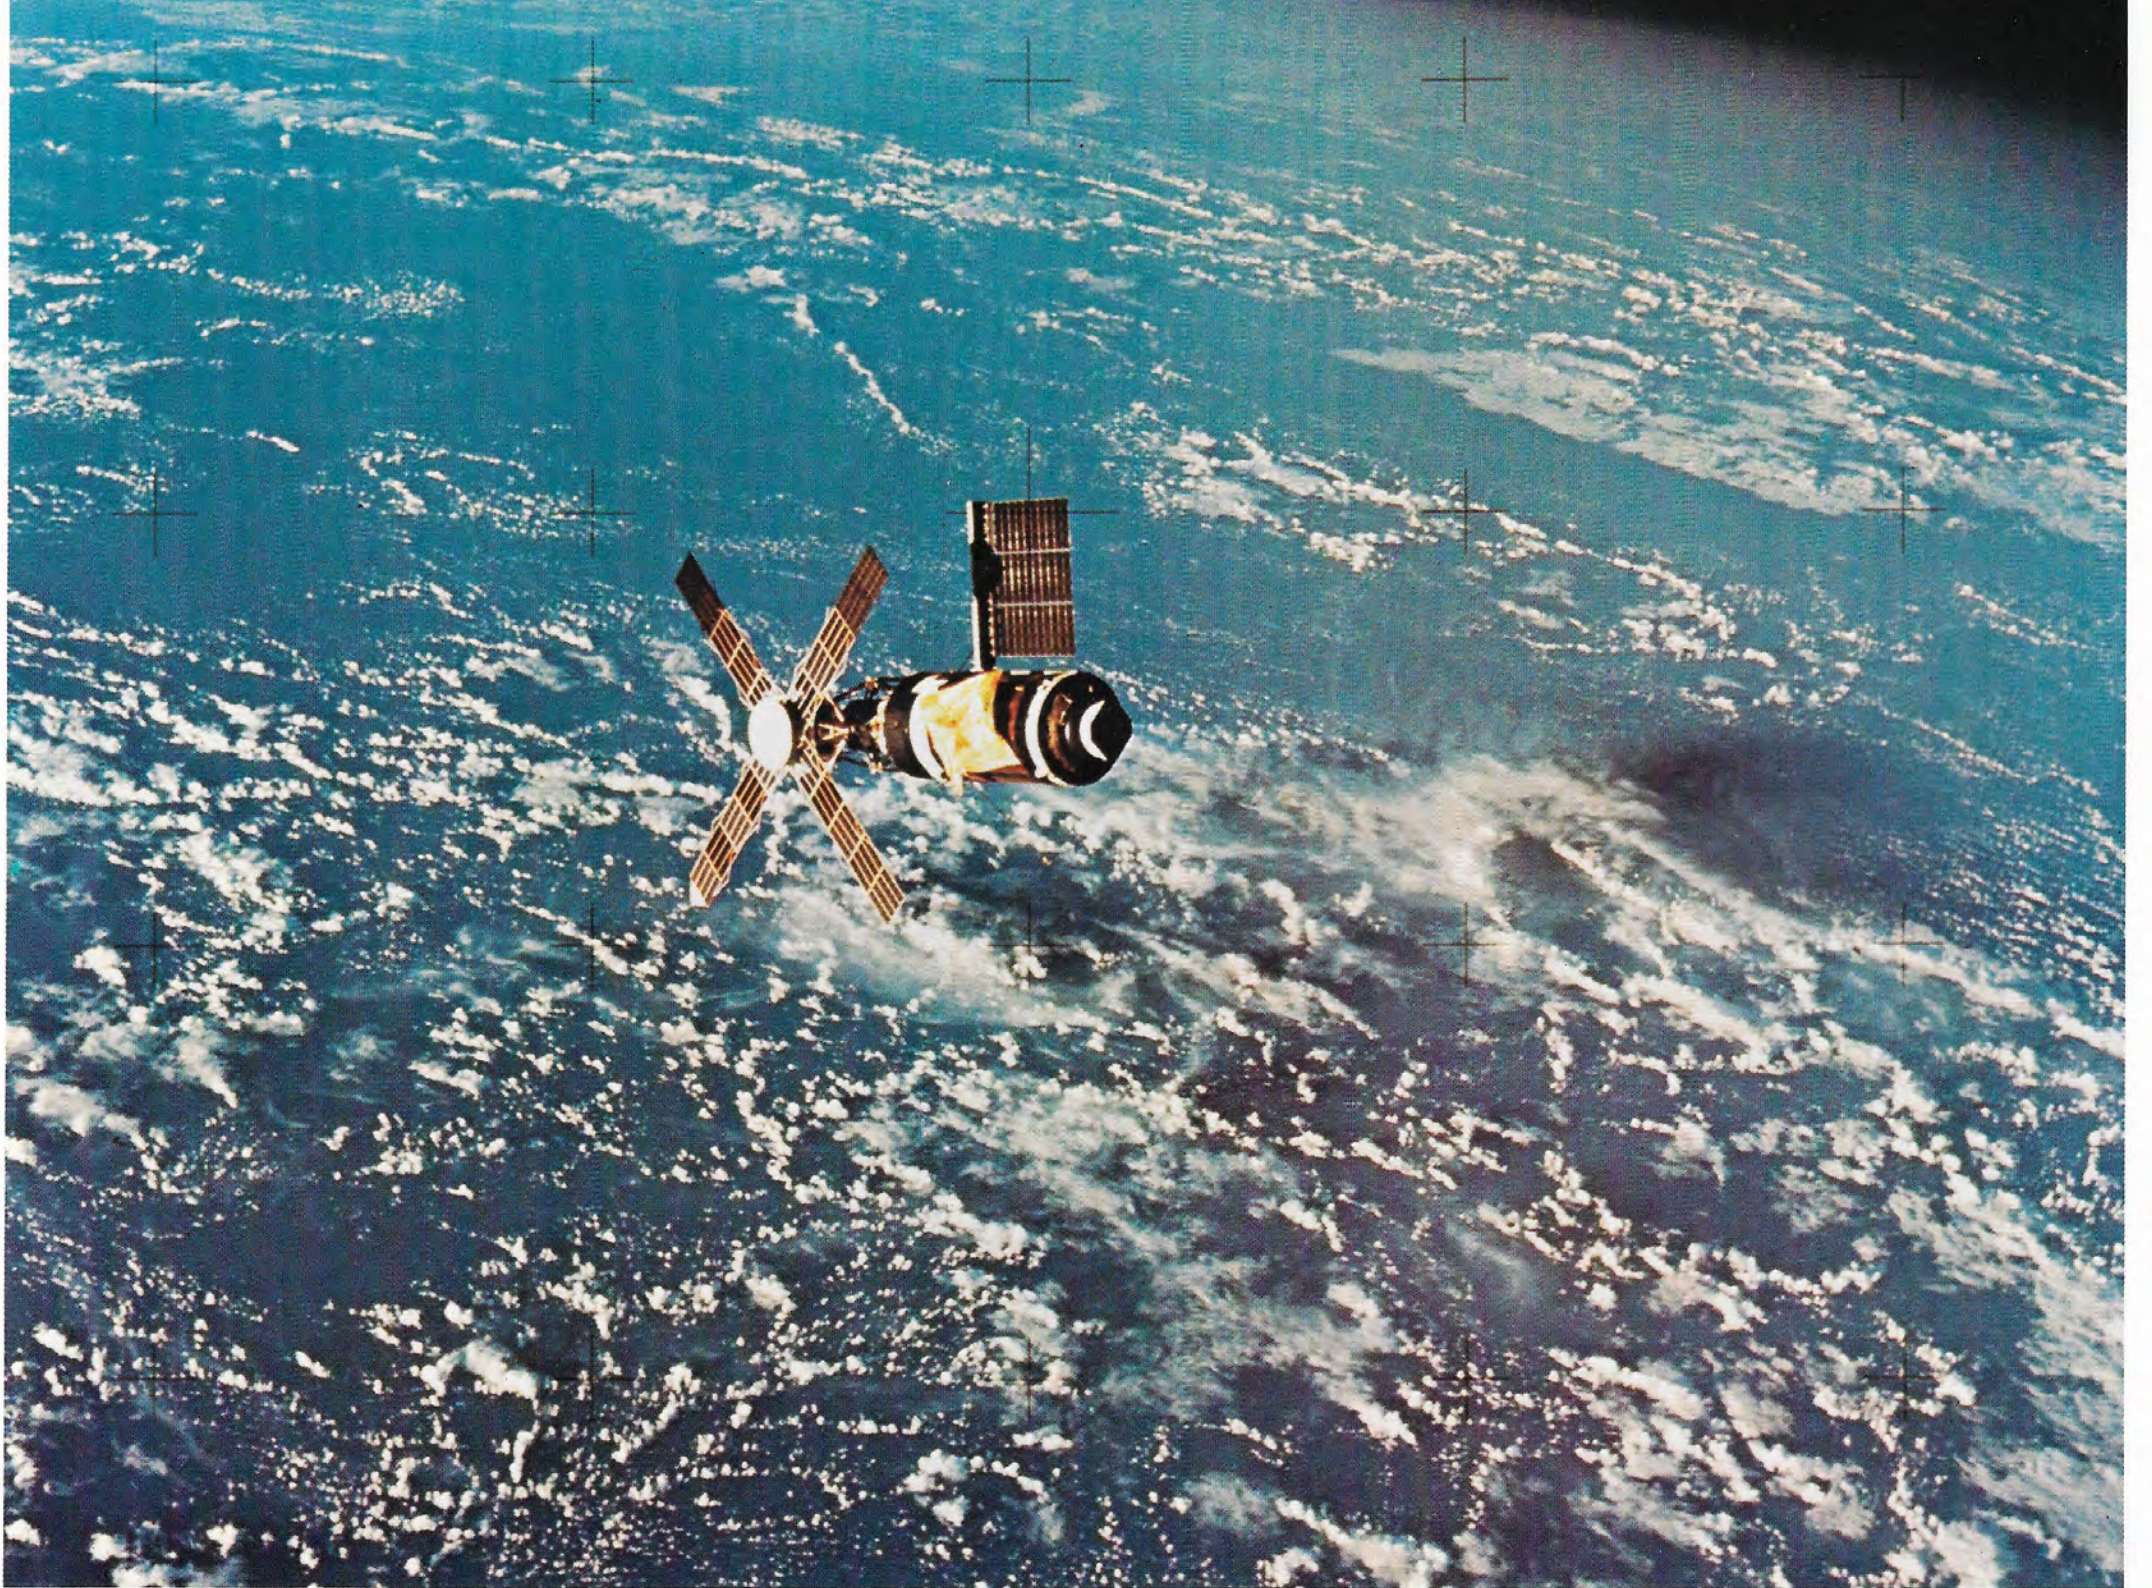
SKYLAB 1-2 ON-BOARD PHOTO—This excellent view of the Skylab 1 space station cluster in Earth orbit was taken from the Skylab 2 Command/Service Module during the final “fly around” inspection of the CSM. Clouds over water are in the background. Note the deployed parasol solar shield which shades the Orbital Workshop where the micrometeoroid shield is missing. The one remaining OWS solar array system wing has been fully deployed successfully. The OWS solar panel on the opposite side is completely missing.
